Re: Notice of Violation (NOV)

Ready Mix USA, LLC - Jersey Pike

NPDES Permit Tracking Number: TNG 110331

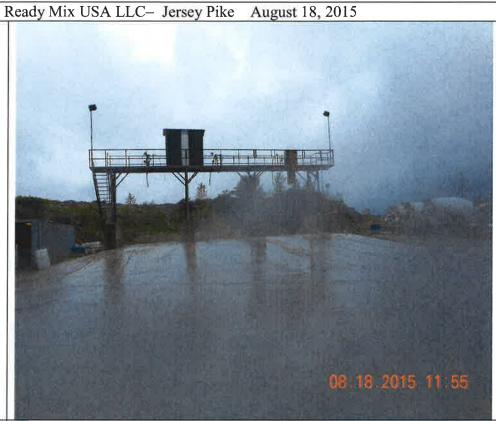
Figure 1.
Truck Parking Area and Washout Station.

The main office, cement silos, and a storage tank are located on the north end of the property. The inspectors observed a truck parking area near the entrance and a truck washout station at the center of the facility (Figure 1). Truck washout water is contained in a series of settling basins and is used as process make-up water. The inspectors also observed aggregate stored in bins at the south and southeast (Figure 2). Excess concrete and block are located along the northeast perimeter. Martin Marietta, a gravel pit, created a berm of rock and debris from their mining operations along the Ready Mix USA's south property line.

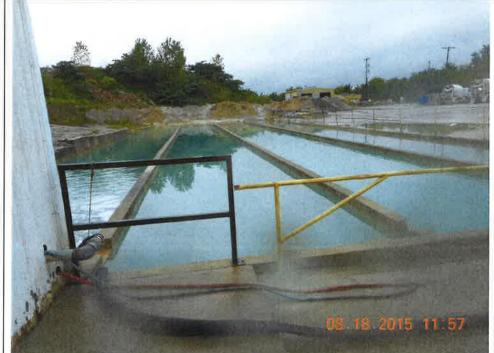
Figure 2.

Settling Basins and Open Aggregate Piles.
